### Inspection Report Minerals Regulatory Program October 15, 2009

<b>Mine Name:</b> Indian Queen	<b>Permit Number:</b> M0010019
<b>Operator Name:</b> Gary Applegate	<b>Inspection Date:</b> 04/21/2009
<b>Inspector(s):</b> Tom Munson	<b>Time:</b> 4PM
<b>Other Participants:</b> none	<b>Mine Status:</b> reclaimed

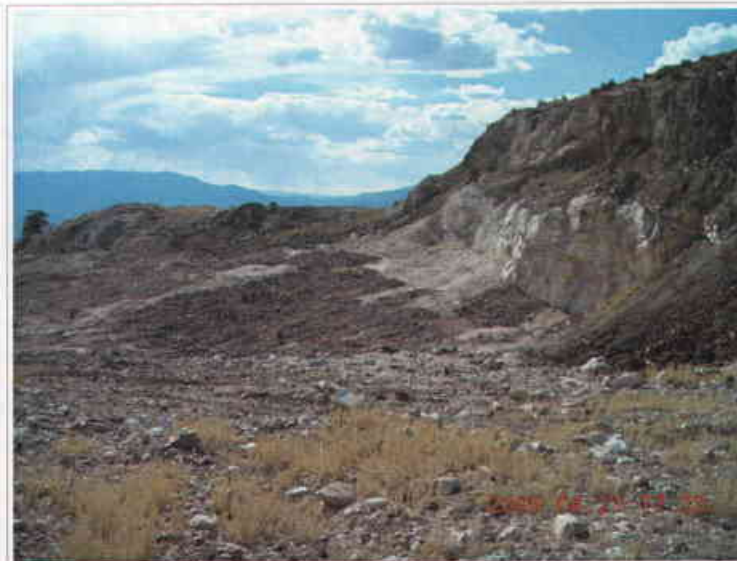
Lower highwall remaining
